PIC18(L)F1XK22 Family Silicon Errata and Data Sheet Clarification

The PIC18(L)F1XK22 family devices that you have received conform functionally to the current Device Data Sheet (DS40001365F), except for the anomalies described in this document.

The silicon issues discussed in the following pages are for silicon revisions with the Device and Revision IDs listed in [Table 1](#). The silicon issues are summarized in [Table 2](#).

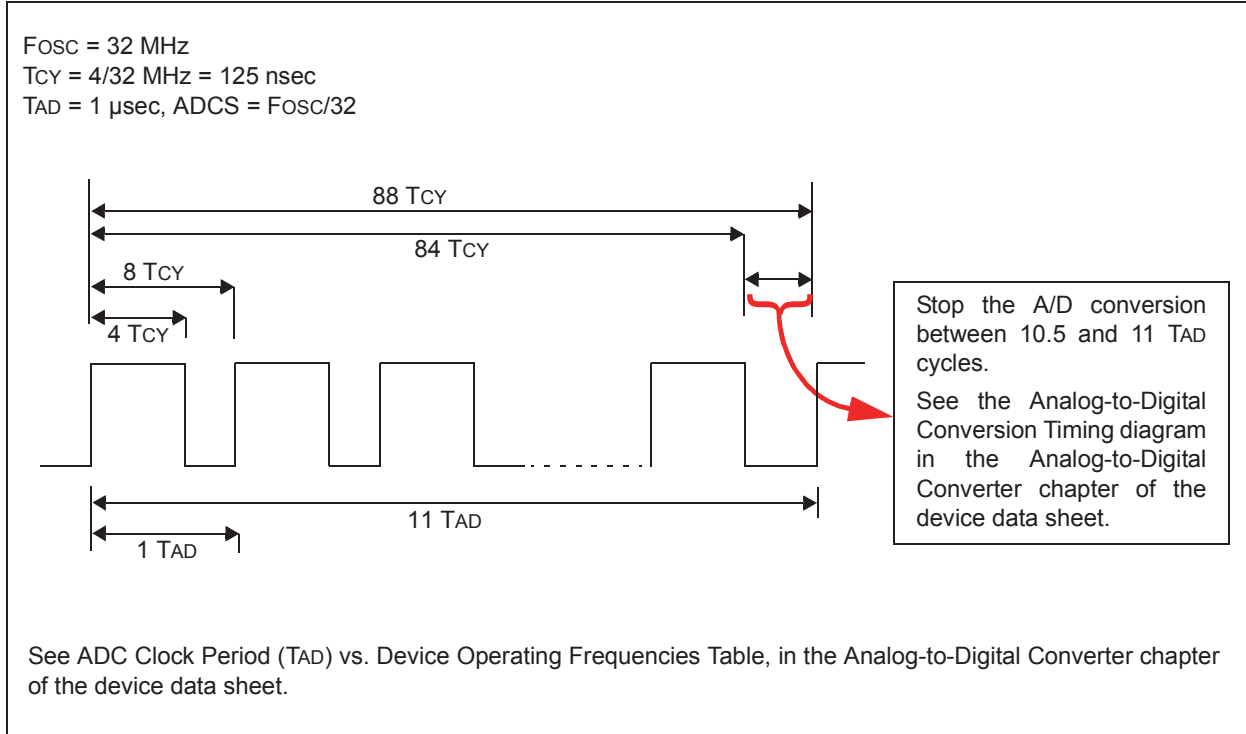
FIGURE 1: INSTRUCTION CYCLE DELAY CALCULATION EXAMPLE

1.2 ADC Conversion Does Not Complete

An ADC conversion may not complete under these conditions:

1. When Fosc is greater than 8 MHz and is the clock source used for the ADC converter.
2. The ADC is operating from its dedicated internal FRC oscillator and the device is not in Sleep mode (an Fosc frequency).

When this occurs, the ADC Interrupt Flag (ADIF) does not get set, the GO/DONE bit does not get cleared, and the conversion result does not get loaded into the ADRESH and ADRESL result registers.

In Figure 1, 88 instruction cycles (T_{CY}) will be required to complete the full conversion. Each T_{AD} cycle consists of eight T_{CY} periods. A fixed delay is provided to stop the A/D conversion after 86 instruction cycles and terminate the conversion at the correct time as shown in the figure above.

Note: The exact delay time will depend on the T_{AD} divisor (AD_{CS}) selection. The T_{CY} counts shown in the timing diagram above apply to this example only. Refer to Table 3 for the required delay counts for other configurations.

Method 3: Method 3 is provided if the application cannot use Sleep mode and requires continuous operation at frequencies above 8 MHz. This method requires early termination of an ADC conversion. Provide a fixed time delay in software to stop the Analog-to-Digital conversion manually, after all ten bits are converted, but before the conversion would complete automatically. The conversion is stopped by clearing the GO/DONE bit in software. The GO/DONE bit must be cleared during the last ½ TAD cycle, before the conversion would have completed automatically. Refer to [Figure 1](#) for details.

For other combinations of F_{OSC} , T_{AD} values and Instruction cycle delay counts, refer to Table 3.
